# PERFORMANCE OF PLAIN CONCRETE RUNWAY PAVEMENT

By I. Ahmed,<sup>1</sup> M. H. Rahman,<sup>2</sup> S. M. Seraj,<sup>3</sup> and A. M. Hoque<sup>4</sup>

**ABSTRACT:** This paper investigates the causes of poor performance of plain cement concrete pavement, the most common type of construction for airfield pavements. Plain concrete pavements are generally cost-effective and durable. The runway at Zia International Airport at Dhaka (Bangladesh) is a plain concrete pavement, which failed rather prematurely. Thin longitudinal cracks occurred in the slab panels even before the runway was opened to traffic. With the operation of air traffic, cracks in the pavement became wider, fragmenting the slab panels into several pieces. This paper is aimed at identifying the causes of poor performance of the plain cement concrete runway pavement at Zia International Airport. A critical review of the various available documents supported by experimental and numerical investigations is presented to unearth the real causes of failure. It is shown that improper spacing of the longitudinal and transverse joints and existence of high temperature stresses resulted in cracking of the slab even prior to ap

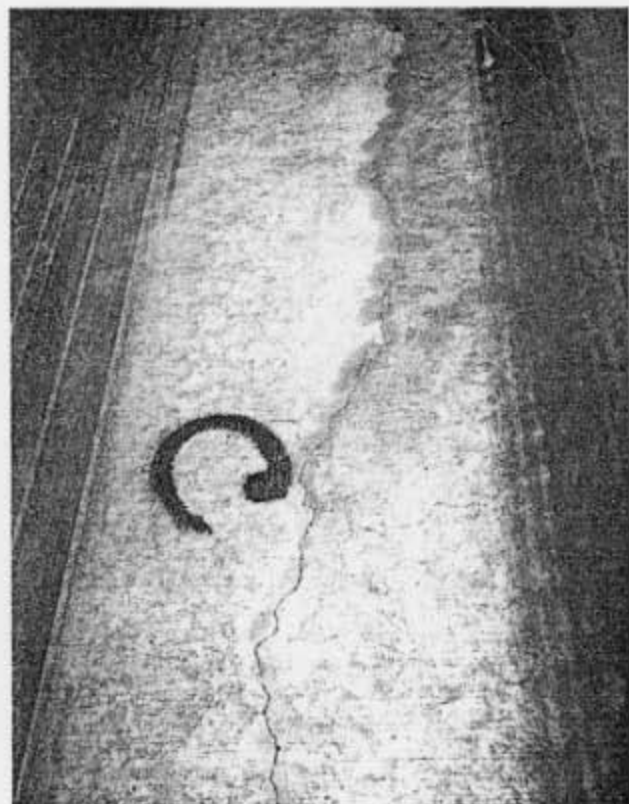
FIG. 2. Typical Crack in Runway Pavement

Many cracks have developed on the pavement of the runway (see Fig. 2 for a typical crack). Cracks have also occurred in the taxiway and in the aprons. Portions of the runway that are unlikely to have experienced any aircraft loading also contain thin longitudinal cracks. It has been reported that such cracks did exist in the runway even before the runway was opened to traffic in 1981. In the course of repetition of heavy aircraft load, progressive development of cracks, both in number and size (width), has taken place. The Civil Aviation Authority of Bangladesh (CAAB) has been routinely repairing various types of cracks by adopting different techniques. Fig. 3(a) shows large-size non-interconnected relatively straight cracks with saw cut marks on either side. Usually a 150 mm (6 in.) wide and 75 mm (3 in.) deep trench is cut around the cracks and filled with asphalt concrete during the course of repair work. Fig. 3(b) shows random and interconnected wide cracks where trench cutting, similar to that shown in Fig. 2, is not feasible, and any attempt of groove cutting may cause extensive damage to the runway slab. In such cases, usually 50 mm (2 in.) diameter holes through the entire slab on 0.6 m (2 ft) centers along the cracks are drilled [see Fig. 3(b)] and filled with surface course asphalt concrete under pressure.

The PCC slabs of the runway suffered severe cracking. The cracks were longitudinal linear cracks spread over the entire length of the runway. Most slab panels near the runway center line underwent multiple cracks, with some of the panels shattered near the touchdown and takeoff areas of the runway. It was reported that cracks of relatively narrow width existed years before the runway was put into operation. Over the years, after being put into service, aircraft wheel loads led to a progressive widening of the cracks as well as development

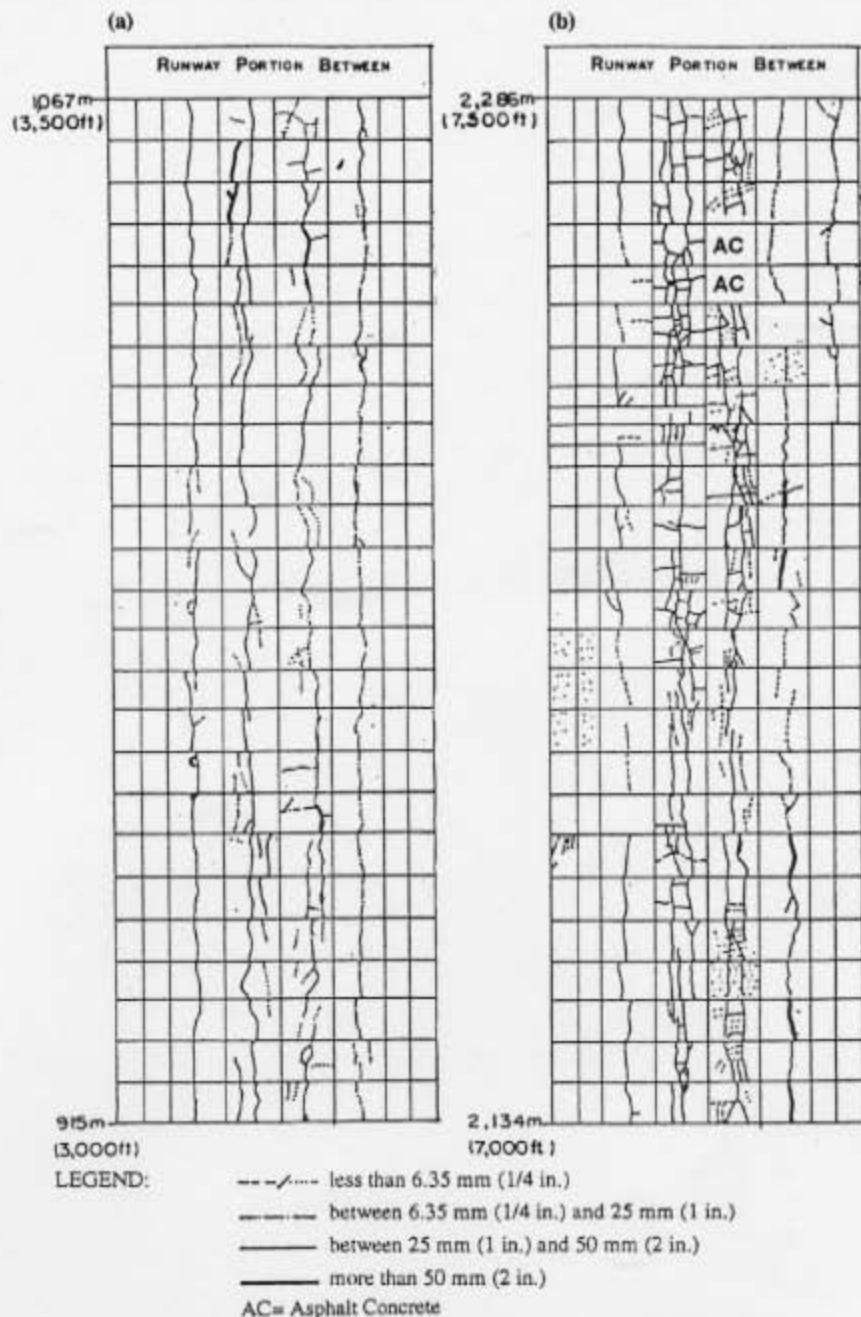
FIG. 4(a,b). Crack Pattern at Different Locations of Runway

Typical crack patterns for chainages 915 m (3,000 ft)–1,069 m (3,500 ft); 2,134 m (7,000 ft)–2,286 m (7,500 ft); 2,286 m (7,500 ft)–2,438 m (8,000 ft); and 2,896 m (9,500 ft)–3,048 m (10,000 ft) are shown in Figs. 4(a,b) and 4(c,d). Average values of degree of crack for these portions of the runway are shown in Table 2. The central slab panels (two slabs adjacent to the centerline) have been subjected to severe cracks of 25 mm (1 in.) width or greater.

It can be seen from Figs. 4(a,b) and 4(c,d) that most of the cracking took place in the central four panels spread over a width of 30.5 m ( $4 \times 7.625$  m), i.e., 15.2 m (50 ft) on either side of the centerline. The panels along the edges are almost free from cracks. This is essentially true when edge slab panels have longitudinal joints spaced 3.8 m (12.5 ft) apart. The location of the wheels for different types of aircraft is shown in Fig. 5. The edge panels were unlikely to experience any wheel load, and as the cracks in the edge panels only occurred in the slabs having longitudinal joints spaced 7.6 m (25 ft) apart, it may be concluded that the initiation of crack was due to improper spacing of the joints in the unreinforced concrete slabs. For central slabs, longitudinal cracks were formed initially in the same fashion as in the case of edge slab panels, and then progressive cracks were developed with the multiple application of heavy loads.

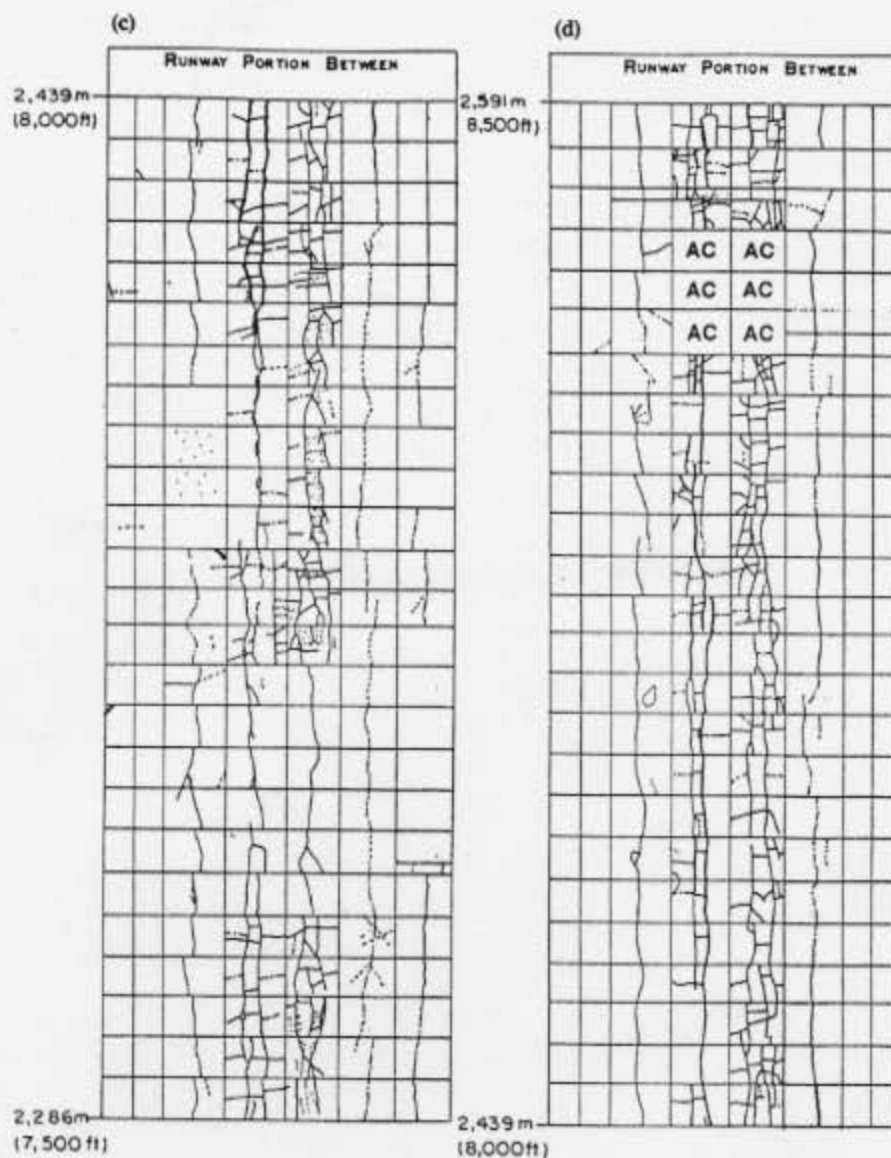
FIG. 4(c,d). Crack Pattern at Different Locations of Runway

Chainage location m(ft) (1)	Degree of cracking* cm/m <sup>2</sup> (2)	Remarks (3)
914-1,067 (3,000-3,500)	18.7	Portion of runway experiencing load from landed aircraft
2,134-2,286 (7,000-7,500)	29.9	Takeoff/touchdown zone
2,286-2,438 (7,500-8,000)	31.2	Takeoff/touchdown zone
2,896-3,048 (9,500-10,000)	24.8	Portion of runway experiencing load from aircraft to depart

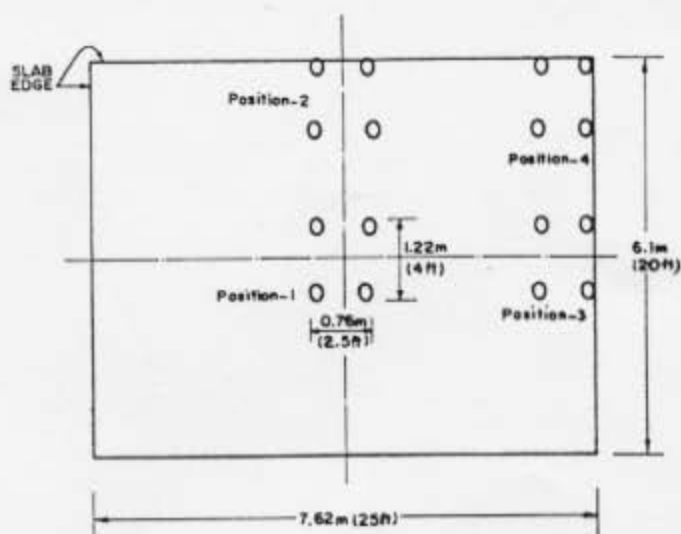
FIG. 6. Positions of Dual Tandem Gear Wheel Configuration Considered for Pavement Analysis

Position of wheel (see Fig. 6) (1)	Maximum tensile stress N/mm <sup>2</sup> (psi) (2)	Maximum compressive stress N/mm <sup>2</sup> (psi) (3)
1	6.1 (880)	6.3 (910)
2	7.8 (1,125)	6.8 (993)
3	3.5 (514)	3.0 (430)
4	3.7 (530)	7.2 (1,040)

Table 6 presents the results of the stress analysis due to the application of the wheel loads. Tensile stresses up to 7.8 N/mm<sup>2</sup> (1,125 psi) were observed for wheels in position 2. For other locations of the wheel, the tensile stresses ranging from 3.5 N/mm<sup>2</sup> to 6.1 N/mm<sup>2</sup> were observed. The lowest value of maximum tensile stresses of 3.5 N/mm<sup>2</sup> occurring for wheel position 3 is in excess of the estimated flexural strength values.

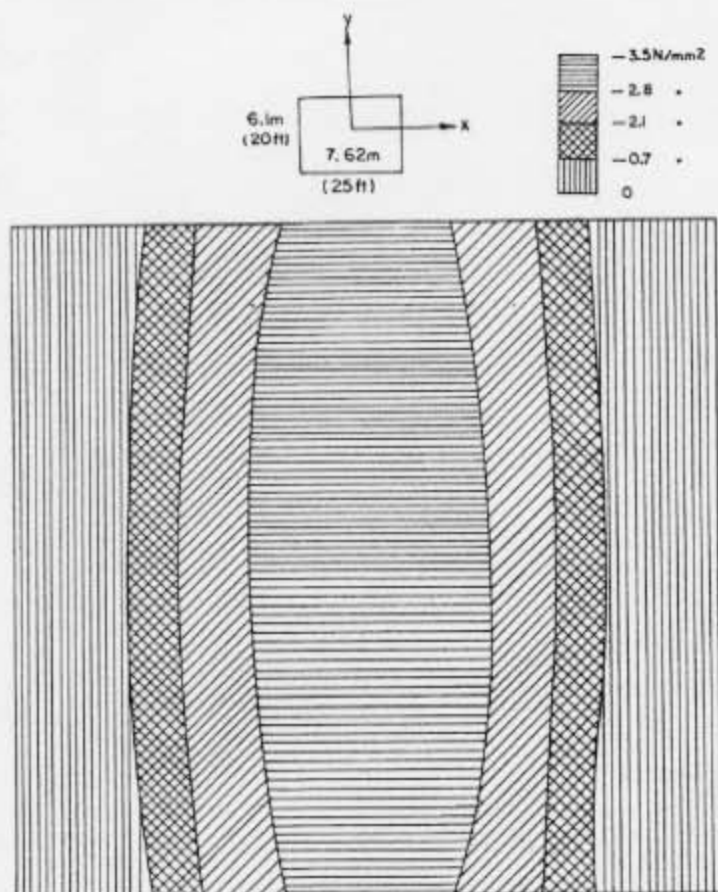
FIG. 7. Top Surface  $\sigma_x$  Stress Contour for Temperature Difference of  $27.5^\circ\text{C}$  ( $50^\circ\text{F}$ )

The stress ( $\sigma_x$ ) contour at the top surface caused solely by the temperature differential of  $27.5^\circ\text{C}$  ( $50^\circ\text{F}$ ) is shown in Fig. 7. The corresponding stress ( $\sigma_y$ ) contour is shown in Fig. 8. On a hot summer day, temperature may produce a transverse tensile stress up to  $3.5 \text{ N/mm}^2$  (510 psi) on the top surface. The deflected shape of the slab for a temperature maximum differential of  $27.5^\circ\text{C}$  ( $50^\circ\text{F}$ ) is shown in Fig. 9. The maximum stress

Recognizing the inherent limitation of the compressive strength to flexural strength conversion, it is suggested that the actual flexural strength available could be much less than that estimated. This suggests that thermal stresses were the primary cause behind the formation of longitudinal cracks prior to the application of the air traffic.

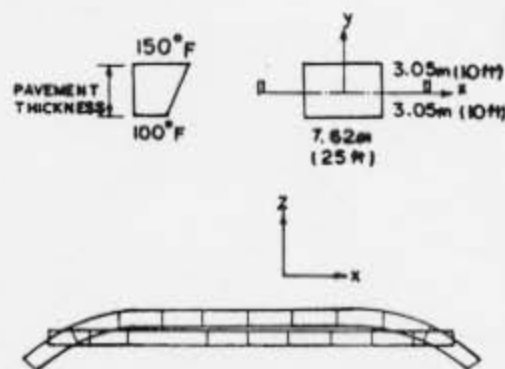
FIG. 9. Deflected Shape of Pavement Slab for Temperature Gradient Shown

occurring in the transverse direction is close to the estimated flexural strength of the pavement concrete (see Table 3).
