# **The Role of Small Diesel Engines in Rural Bangladesh During the 1998 Flood**

**Md. Ehsan, Md. Imtiaz Hossain, Md. Nasir Uddin Miah and Md. Abu Sayed**  
Department of Mechanical Engineering  
Bangladesh University of Engineering and Technology, Dhaka-1000, Bangladesh

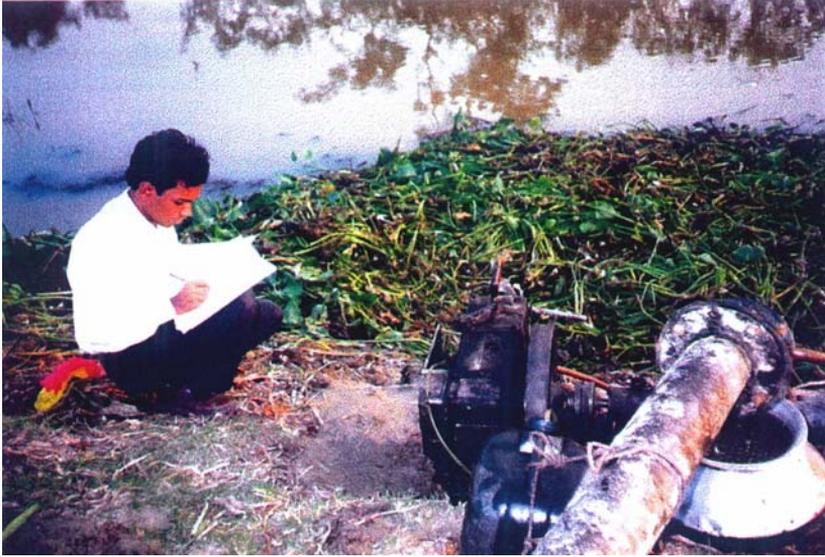
**Figure 2: Inspection of a damaged engine that was used for irrigation in Chandpur**

In the data collection procedure, the first step in each trip was to identify areas where the diesel engines were affected by the flood. Local engine repairing workshops, district BADC offices and public representatives like union chairman/members were found to be good sources of such information. Once the prospective areas were identified, the research engineers visited the engine sites (often in very remote areas which they had to reach on foot or by using country boats) and gathered first hand information from the users, who were very cooperative. The technical data of the engine was taken from its nameplate in most cases. The users also gave information regarding the productivity loss, repair cost and alternative use of the engines during the flood. Figures 2 and 3 show damaged engines at Chandpur and Manikgonj, respectively. Figures 4 and 5 show alternative uses of engines during the flood.

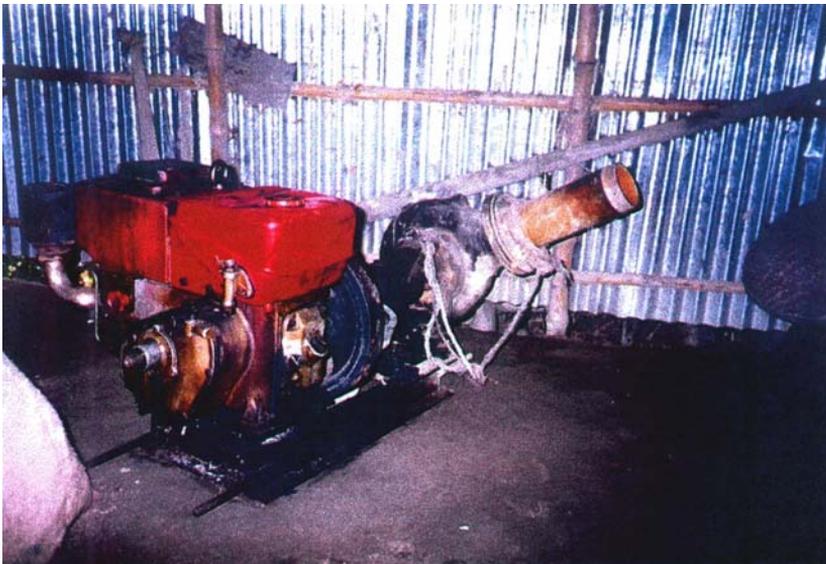
**Figure 3: A partially damaged engine in Manikgonj**

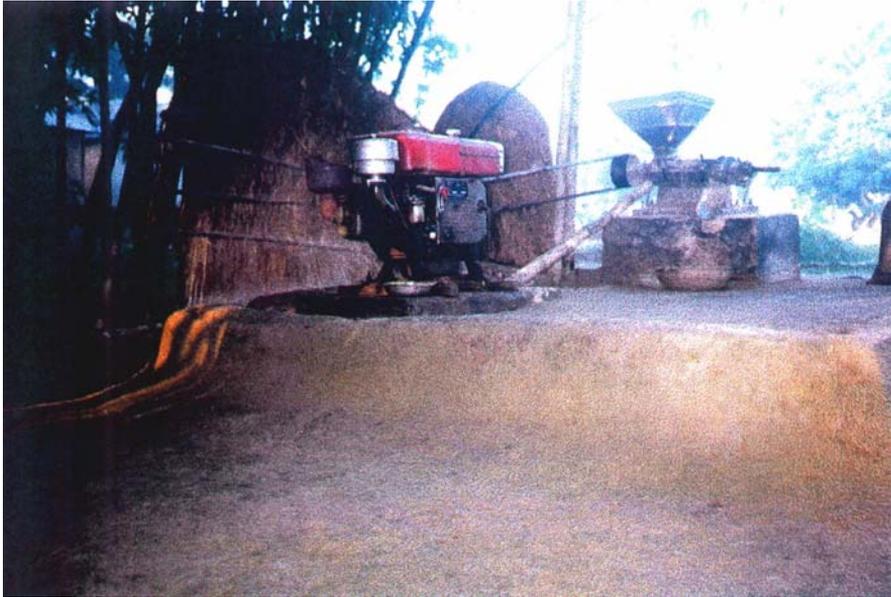
**Figure 4: Alternative use of an engine in a rice mill in Narshindgi**

Most of the small diesel engines are used for irrigation purpose in rural areas without electricity. These are seldom used in areas with electricity, where electric motors running deep tube-well pumps are common. Such electric motors suffered even more damage during the flood. Most of the diesel engines in worst affected areas were not used during the flood (see Fig. 12), although at some places these engines were used for different purposes (see Figs. 4, 5). The main alternative

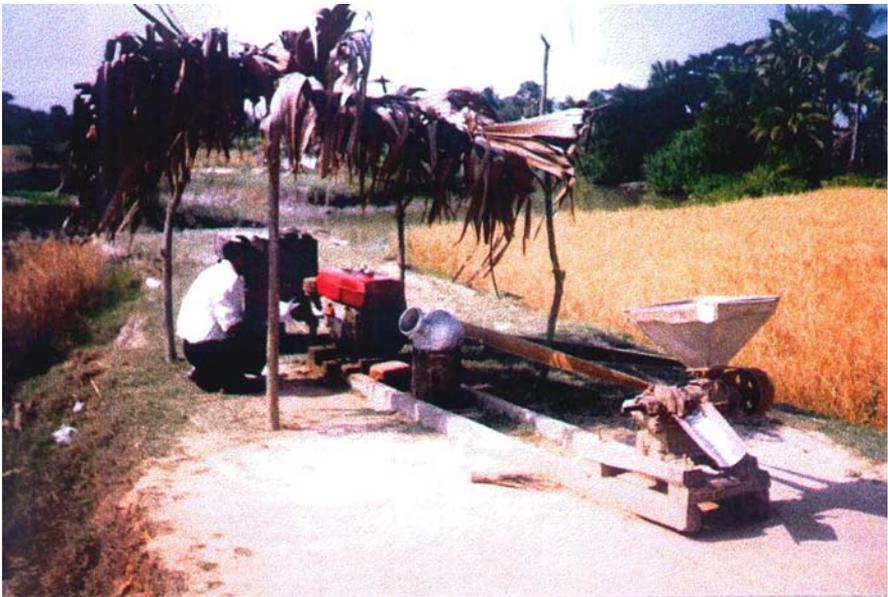
**Figure 5: Alternative use of an engine in a rice mill in Patuakhali**

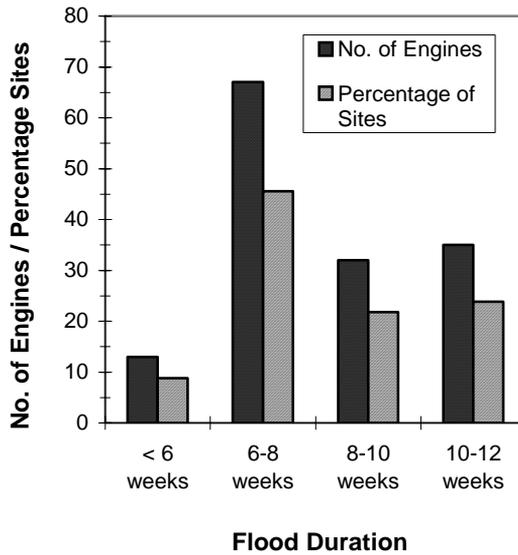
The results of the survey are presented in Figs. 6 through 12. Figures 6 through 8 show different aspects of the 1998 flood in the worst affected areas. Nearly half of the engine sites were flooded for 8 to 12 weeks. The peak water level in the flood affected areas reached as high as 20 feet from the ground. Although the water level reached unusually high levels, in many places these were similar to the levels reached during the 1988 flood. Although the people of Bangladesh are used to limited flood during the rainy season, it was the unusually long duration of the flood that caused the devastation in 1998.

**Figure 6: Duration of the 1998 flood at the inspected sites**

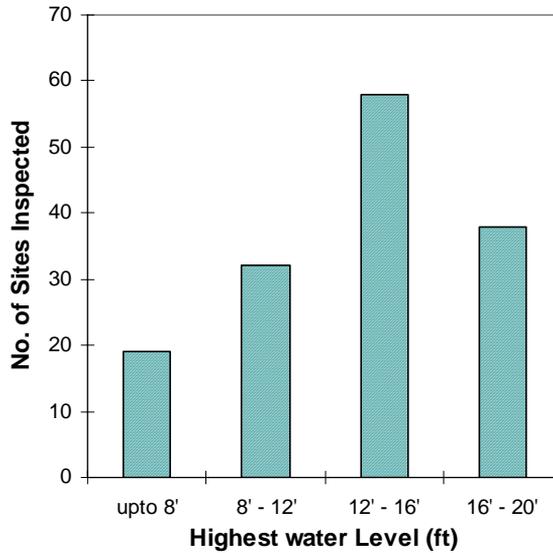
**Figure 7: Peak water levels recorded at the inspected sites**

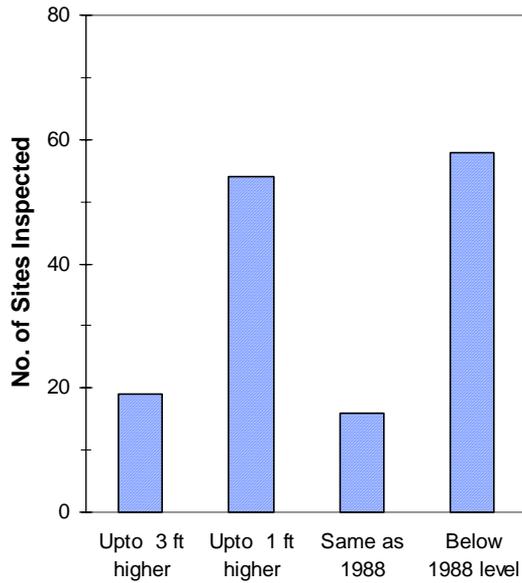
**Figure 8: Comparison of the flood situation in 1998 with that in 1988**

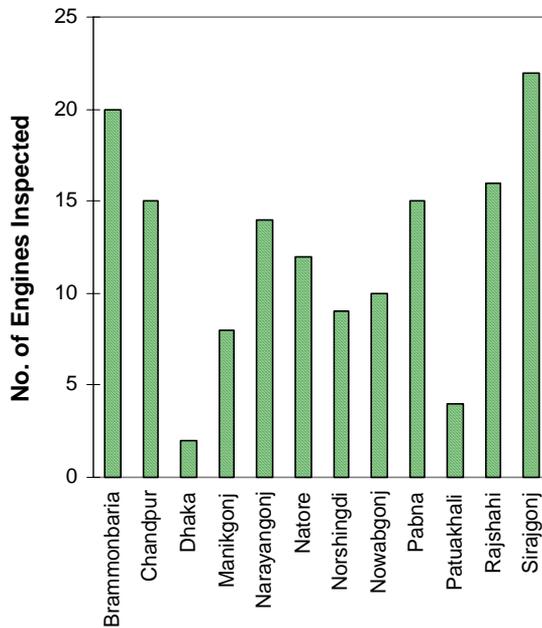
Figures 9 through 12 show the effect of flood on the small diesel engines throughout rural Bangladesh. Figure 9 shows the district wise distribution of the inspected engines. The number of engines affected by the flood increased as more and more area became flooded, starting from the beginning of August and continuing to the end of September. During this period almost all the sites were affected.

**Figure 9: District-wise distribution of inspected engines**

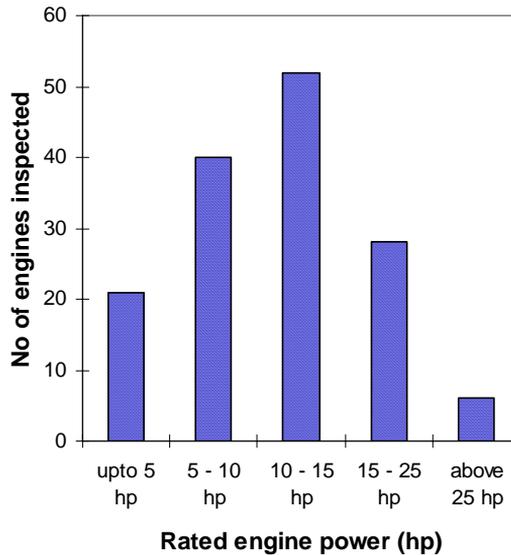
Most of the engines used had rated power of 5-10 hp with rated speed near 2000 rpm. Although having good transportability, more than 80% of the engines suffered at least partial damage during the flood period. This was partly due to unexpected quick rise of water level, which the owners were not prepared for, and partly due to the unavailability of any dry ground at all in many sites.

**Figure 10: Distribution of rated engine power**

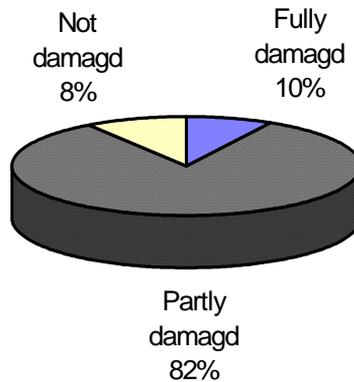
**Figure 11: Damage analysis of inspected engines**

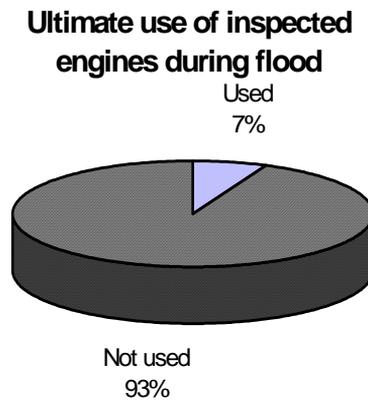
**Figure 12: Ultimate use of inspected engines**

degree of damage was limited and some were effectively protected from flood, in worst affected areas only about 7% of the engines could be used for productive purposes during the flood. The situation was different for moderately affected regions where such engines were effectively used in mechanized boats and for other purposes; (xiv) Repair costs for most of the partly damaged engines have been estimated at about Tk. 2000-5000/-. In many cases, lack of availability of funds for repairing kept the engines out of order even after the flood; (xv) Approximate daily productivity of most of such engines ranged between Tk. 100-300/- per day, which was lost in most cases during the 1998 flood.
