# PERFORMANCE OF PLAIN CONCRETE RUNWAY PAVEMENT

By I. Ahmed,<sup>1</sup> M. H. Rahman,<sup>2</sup> S. M. Seraj,<sup>3</sup> and A. M. Hoque<sup>4</sup>

**ABSTRACT:** This paper investigates the causes of poor performance of plain cement concrete pavement, the most common type of construction for airfield pavements. Plain concrete pavements are generally cost-effective and durable. The runway at Zia International Airport at Dhaka (Bangladesh) is a plain concrete pavement, which failed rather prematurely. Thin longitudinal cracks occurred in the slab panels even before the runway was opened to traffic. With the operation of air traffic, cracks in the pavement became wider, fragmenting the slab panels into several pieces. This paper is aimed at identifying the causes of poor performance of the plain cement concrete runway pavement at Zia International Airport. A critical review of the various available documents supported by experimental and numerical investigations is presented to unearth the real causes of failure. It is shown that improper spacing of the longitudinal and transverse joints and existence of high temperature stresses resulted in cracking of the slab even prior to ap

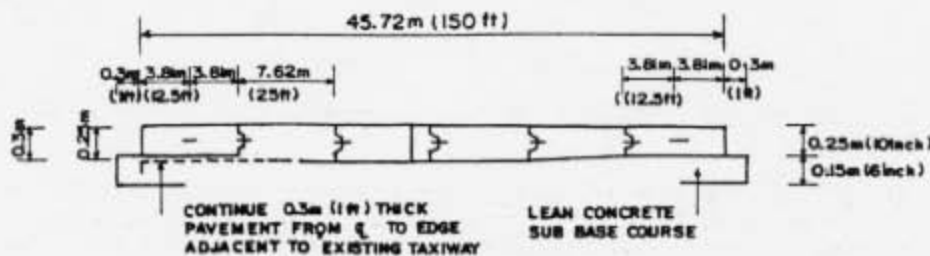
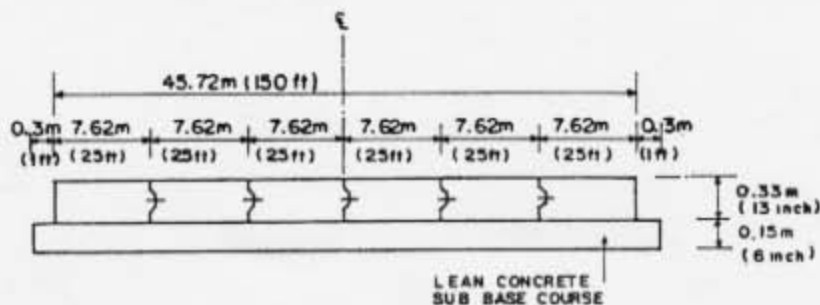
FIG. 1. Typical Runway Pavement Cross Section

RUNWAY [BETWEEN 152.4m (500ft) AND 3048m (10,000ft)]

RUNWAY [BETWEEN 0-152.4m (500ft) AND 3048m (10,000ft) - 3200m (10,500ft) FROM THE SOUTH END]
